RTO MEETING PROCEEDINGS 18

Fatigue in the Presence of Corrosion

Papers presented at the Workshop of the RTO Applied Vehicle Technology (AVT) Panel (organised by the former AGARD Structures and Materials Panel) held in Corfu, Greece, 7-9 October 1998.

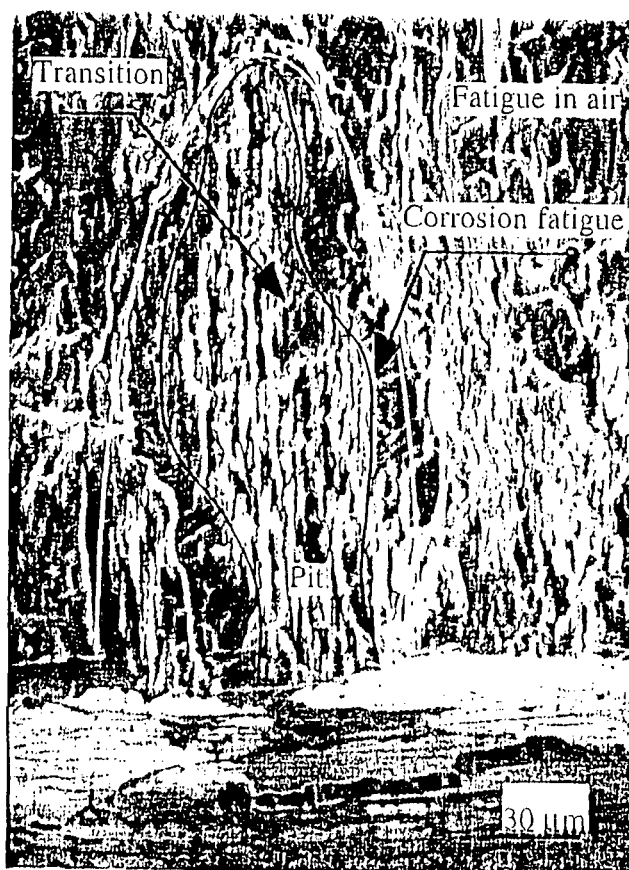
Top, RH side, 2091T351, 1M NaCl, -660 mV(SCE), $\Delta\sigma = 100$ MPa, $R=0.05$, 1 Hz : fully developed corrosion pit, the flaw is elongated with a transition zone, the tip of the pit is in contact with the flaw front.

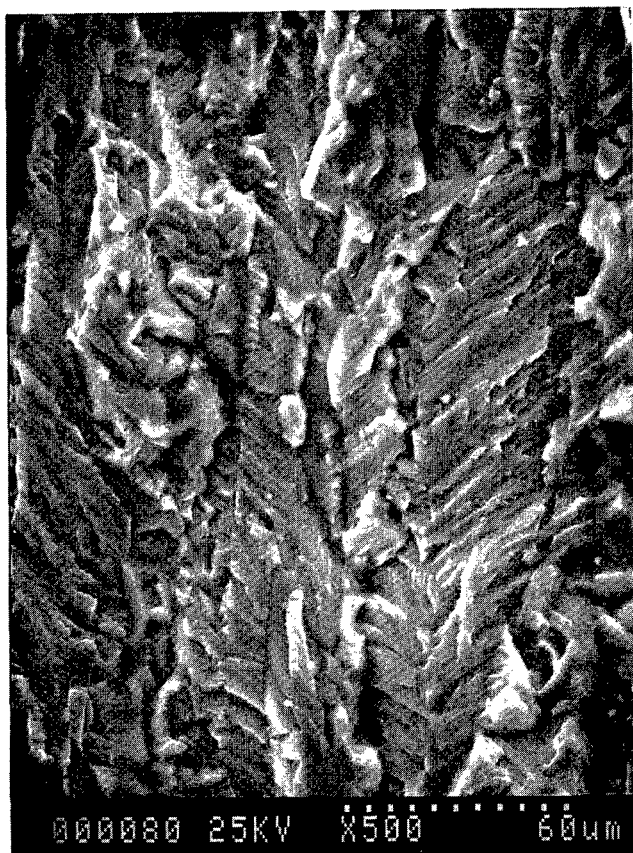
Fig. 11 Fracture surface of 8090 alloy tested in air at 10 Hz (2÷3 mm from the notch).

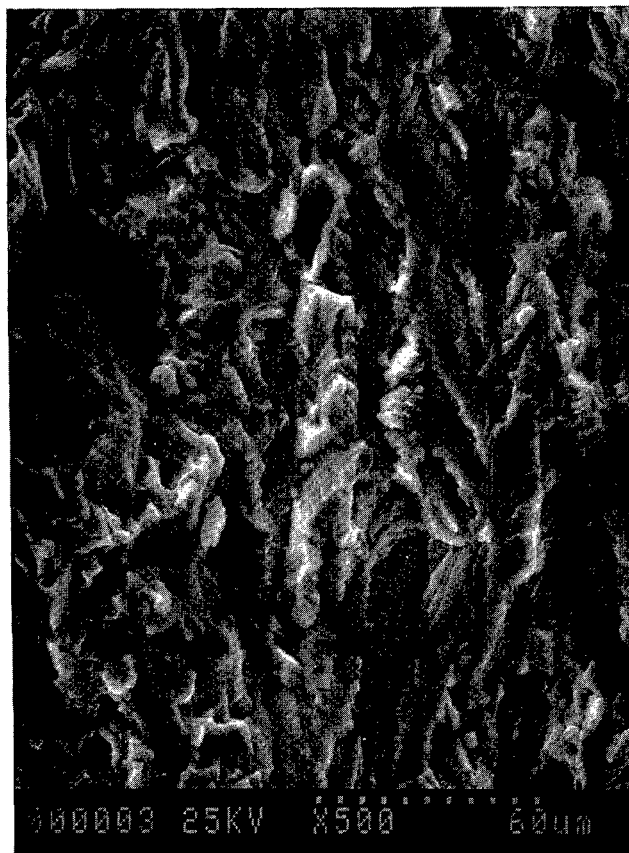
Fig. 12 Fracture surface of 8090 alloy tested in air at 1 Hz (2÷3 mm from the notch).

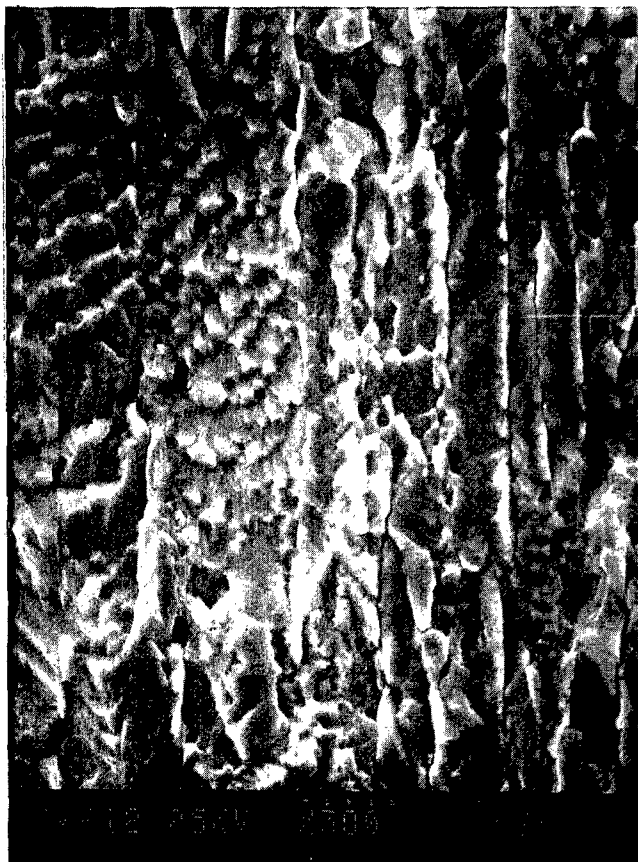
Fig. 15 Fracture surface of 8090 alloy tested in NaCl aqueous solution at 10 Hz (3 mm from the notch).

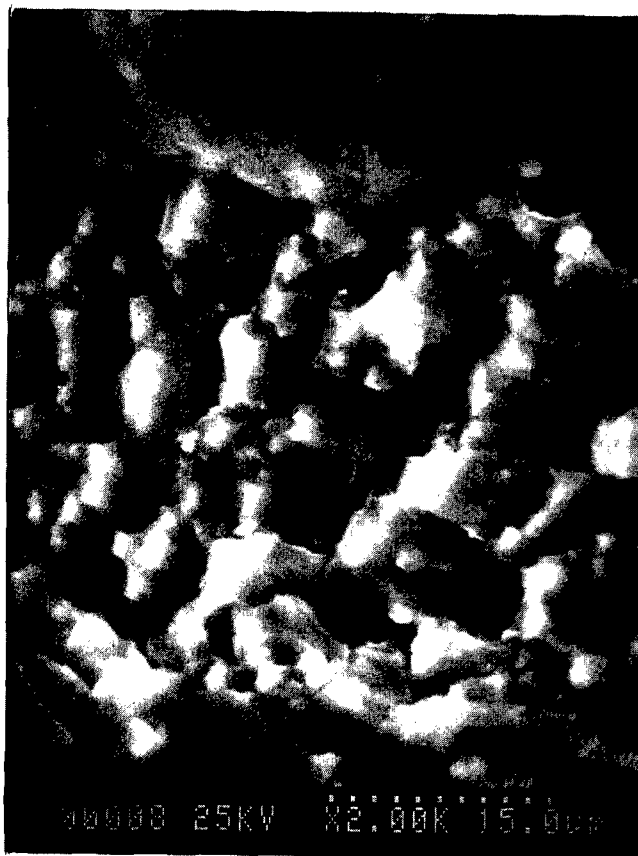
Fig. 17 Fracture surface of 2091 alloy tested in NaCl aqueous solution at 2 Hz (2 mm from the notch).

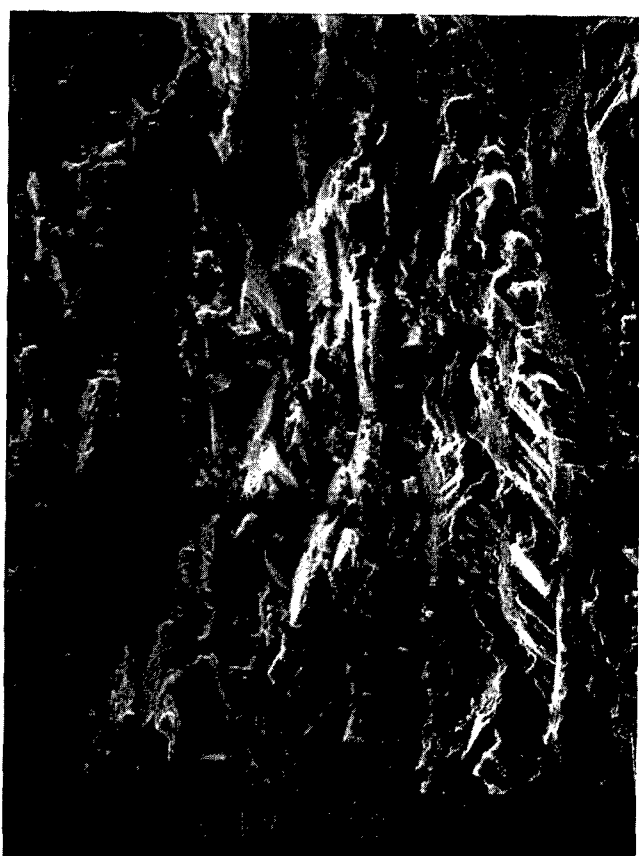
Fig. 18 Fracture surface of 8090 alloy tested in air at 5 Hz (1±2 mm from the notch).
